Our Ref: 1204082 FI 9
Your Ref:
Date: 14 February 2013

MANAGEMENT ASBESTOS SURVEY

1/065A BAY 1, 1/065B BAYS 2 & 3 AND 1/065C
BAYS 4 & 5, 18 STORE,
HM NAVAL BASE,
PORTSMOUTH,
HAMPSHIRE

BAE SYSTEMS SURFACE SHIPS LIMITED

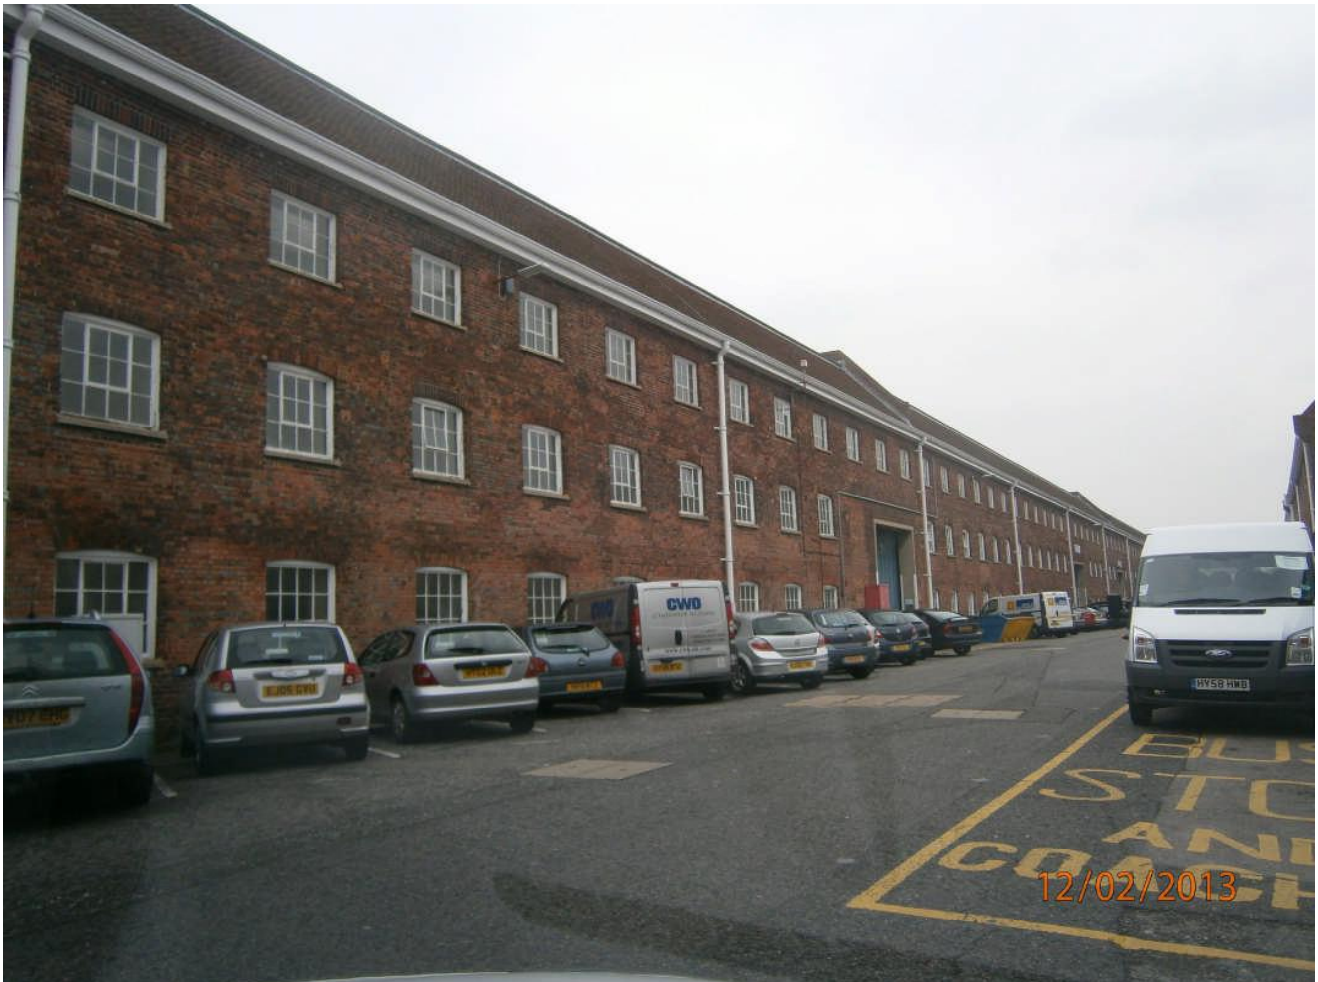
A management asbestos survey was carried out at 1/065B Store Bay 3 and 1/065C Store Bay 4, HM Naval Base, Portsmouth, Hampshire, PO1 3NJ.

- Brick walls
- Metal guttering and downpipes
- Clay tiles to pitched roof
- Metal window frames
- Metal folding doors (x2)
- Non - asbestos woven insulation to cables within electrical box
- Non – asbestos putty surrounding window frames
- Non – asbestos woven covering to lightning conductors within drain pipes (x6)

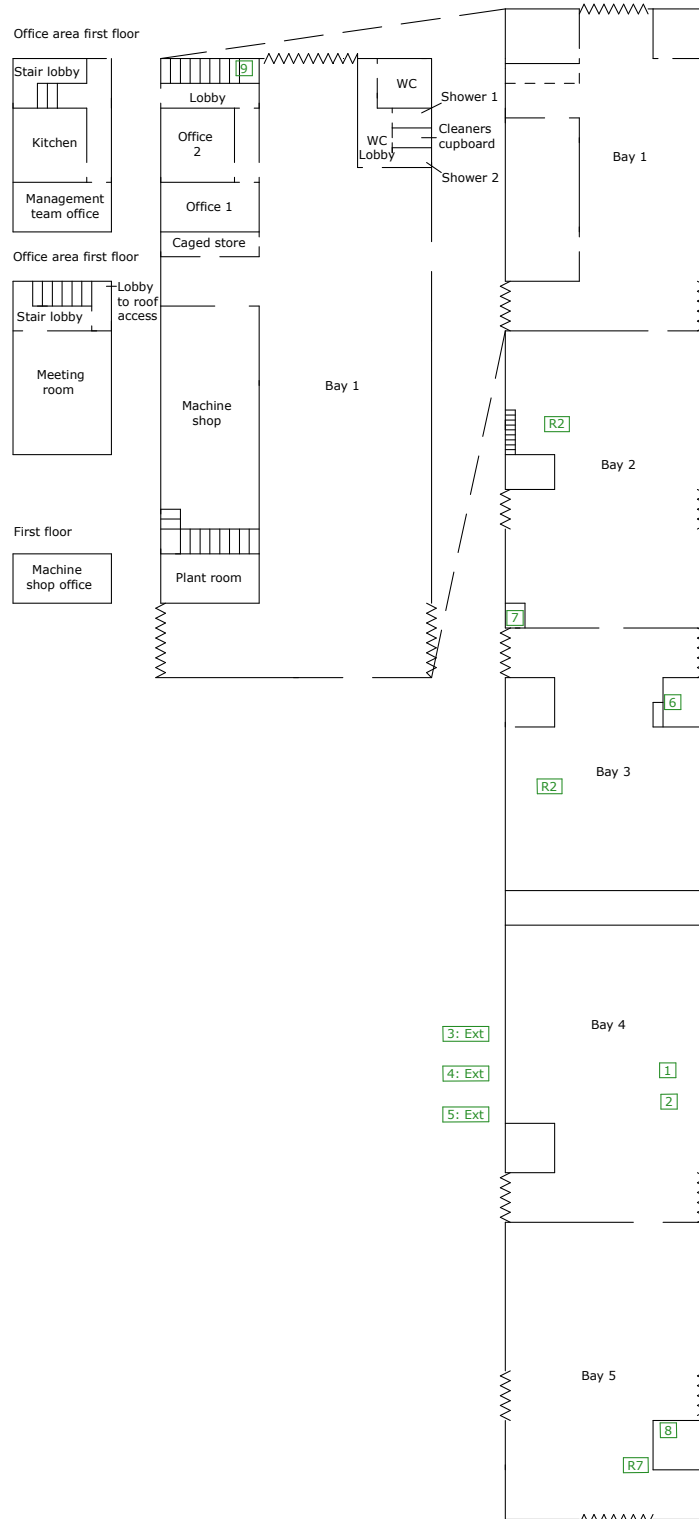
Client: BAE Systems Surface Ships Limited
Site: 1/065A Bay 1, 1/065B Bays 2 & 3 and 1/065C Bays 4 & 5, 18 Store,
HM Naval Base,
Portsmouth,
Hampshire,
PO1 3NJ

Key: 1 No asbestos identified
R1 No asbestos strongly presumed
