HMS Trincomalee – Ships Figurehead  
National Museum of the Royal Navy

## Treatment Proposals

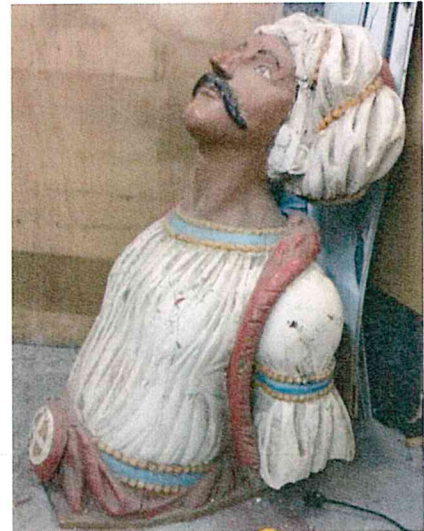
**Description:** Carved and painted ships figurehead depicting a man in a turban. Probably oak but possibly elm, paint likely to contain lead.

**Condition:** Becoming poor: most significantly long term decay of the timber substrate has led to many significant losses to both decorative detail and main structure, drastically affecting stability and integrity. There are various large splits and voids in the main carcass plus evidence of previous repairs (of varying quality and suitability) which have begun to alter the original presentation of the figure. Along with old repairs and additions the figure appears to have been over-painted several times and the thickness of the paint contributes to the general poor appearance, as does the heavy surface dirt and many accretions and abrasions. The crown of the turban appears to be copper sheet, at least in part, and the originality of this element will need to be ascertained as it may have been an element added to protect end grain.

**Treatment:** The over-paint is disguising the true condition of the figurehead and the quality of previous repairs, which may well be contributing to deterioration – for example a common repair in the past has been the addition of fibreglass which actually prevents the timber from taking up or releasing moisture with seasonal humidity changes. In addition the over-paint will, at best, hinder or, more likely, prevent essential access for the chemicals needed to halt decay and consolidate the main timber structure. There is, therefore, a strong argument for removal of the paint layers to allow full assessment and treatment of the timber. Such removal is, of course, an ethical challenge to the full story of the figurehead but, to satisfy the historic record that is the successive paint layers, a small archival patch of each paint layer can be revealed and left in-situ as a permanent record. The original colours and scheme will be revealed in this way. It may be that the paint removal needs to be done mechanically but it is more likely to be a solvent based process. The precise solvent will need to be established with tests but I would anticipate that a dichloromethane solution is the likeliest candidate – whichever method proves most suitable, each paint layer can be discovered and recorded through the process. Lead based paint needs suitably safe conditions for its removal and disposal.

Once the original timber surface is revealed the full extent of the decay will become much clearer and can be addressed with a liquid fungicide for rot, a liquid based consolidant to give strength to the rot weakened areas and timber inserts to replace the losses. Where possible a timber chosen to match the original will be used – I have a stock of reclaimed timber for the purpose – but there may be protective or practical reasons to use an alternative, permission/discussion would always be sought first. New inserts will be carved to continue the shaping of the figurehead and complete its main structure.

The restored figurehead can finally be painted to match the established original scheme. I would suggest an acrylic based paint medium as it is inert and readily reversed but this would need the figurehead to remain indoors for display purposes. The paint can also be waxed for long term protection. I also understand a new mount will be needed to facilitate future display.
